**RE: AHERA 3-Year Reinspection  
Cardinal O'Connell Early Learning Center  
21 Carter Street  
Lowell, Massachusetts  
EFI Project No. 014.07795**

EFI Global Inc. (EFI) is pleased to present this AHERA 3-Year Reinspection Report prepared for the Cardinal O'Connell Early Learning Center located at 21 Carter Street, Lowell, Massachusetts (Site). The reinspection site visit was conducted on February 21, 2024, and the corresponding report was completed in accordance with the United States Environmental Protection Agency (USEPA) Asbestos Hazard Emergency Response Act (AHERA) regulations (40 CFR 763) and Massachusetts Department of Labor Standards "Requirements for Schools Subject to AHERA" regulations (454 CMR 28.13).

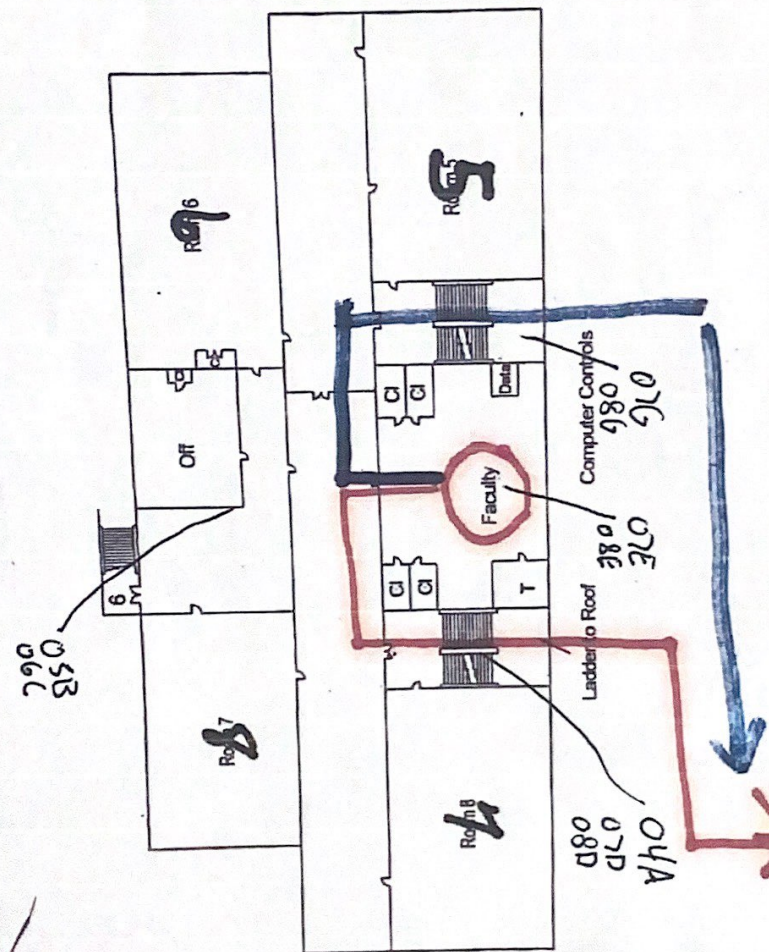
2nd Floor

District Name:	Lowell Public Schools
School Name:	Cardinal O'Connell Alternative School
Address:	21 Carter Street Lowell, MA 01852
